Maximizing the Lifespan of Open-Graded Friction Course on South Carolina Highways

A Certified Public Manager Research Project

February 2019

District Engineering Administrator

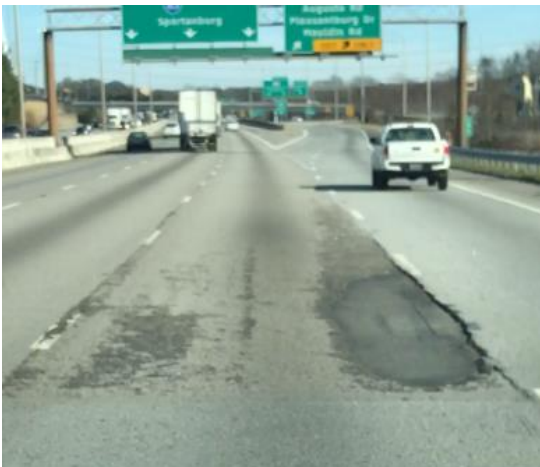
Figure 1

OGFC has an intended service life of 10 years. However, localized failures have been observed on many of South Carolina's interstates within the first 3 – 5 years. The failures are usually less than 100' in length and are directly adjacent to OGFC that performs well for many years after the localized failure occurs. **Figures 1 and 2** show examples of these localized, premature failures.

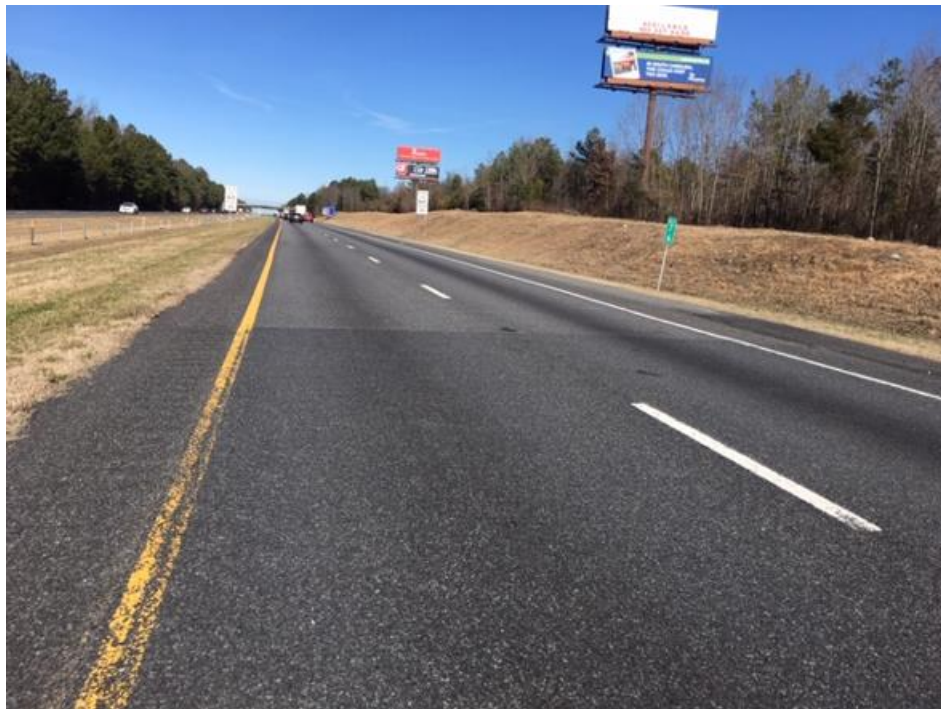
**Good Cold Joints in Both Lanes – I-77 NB at Mile Point 76
These joints were paved in 2014**

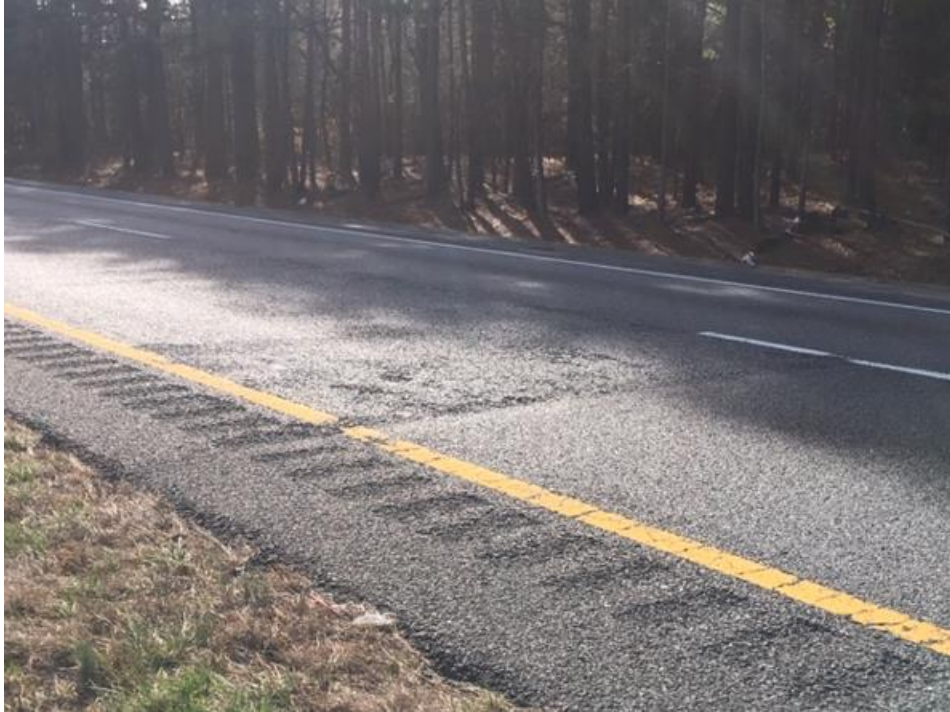
Bad Cold Joint – I-77 SB at Mile Point 69.80
This joint was paved in 2013

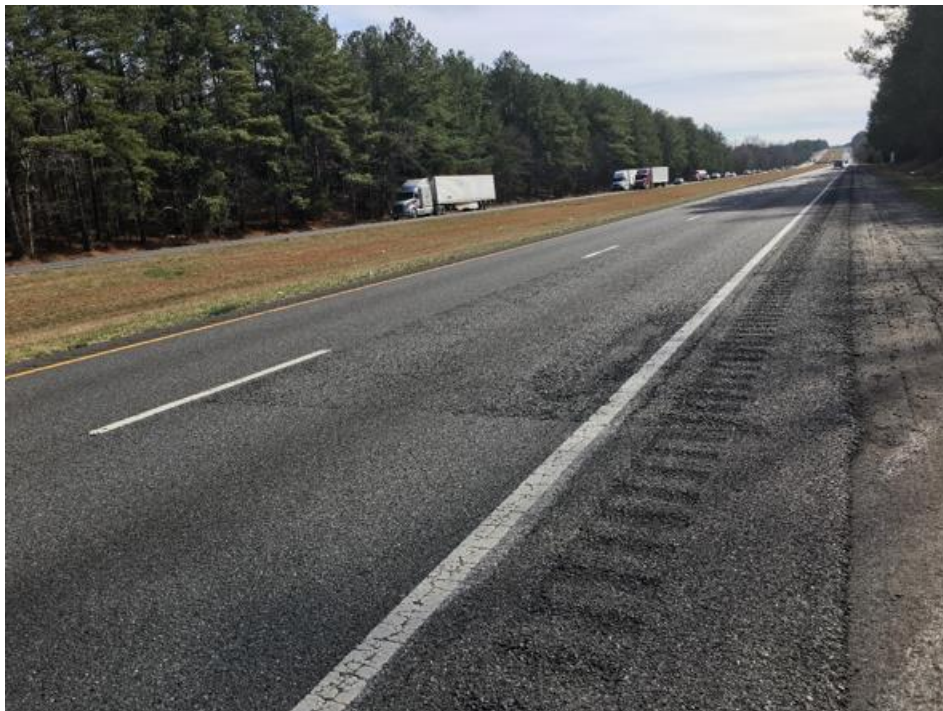
Bad Cold Joint – I-77 SB at Mile Point 69.10
This joint was paved in 2013

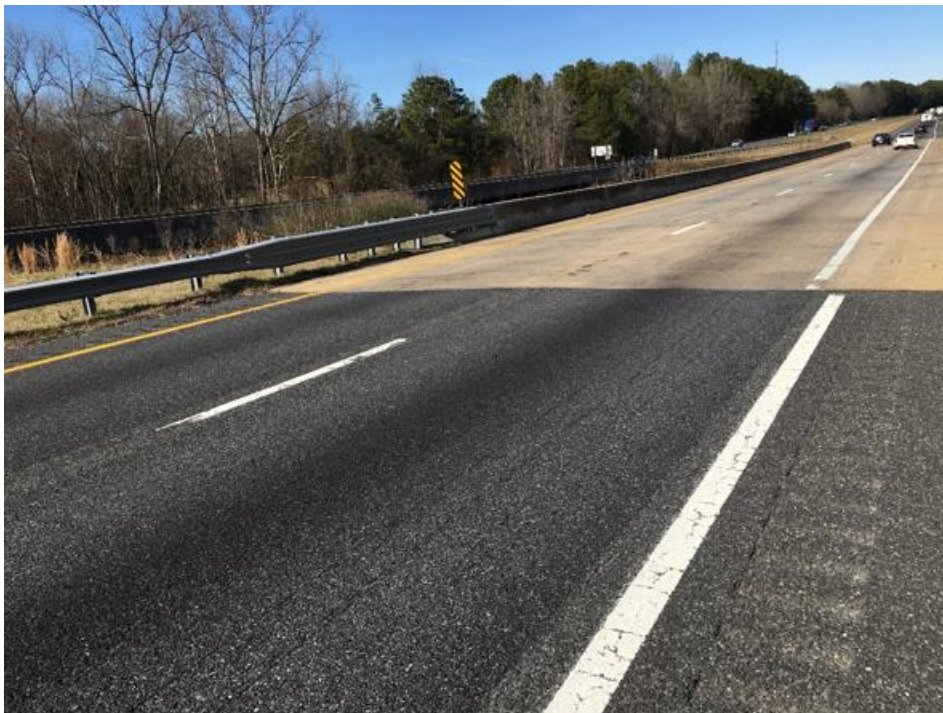
Good Bridge Approach Joints – I-77 NB at Mile Point 67.20
These joints were paved in 2013

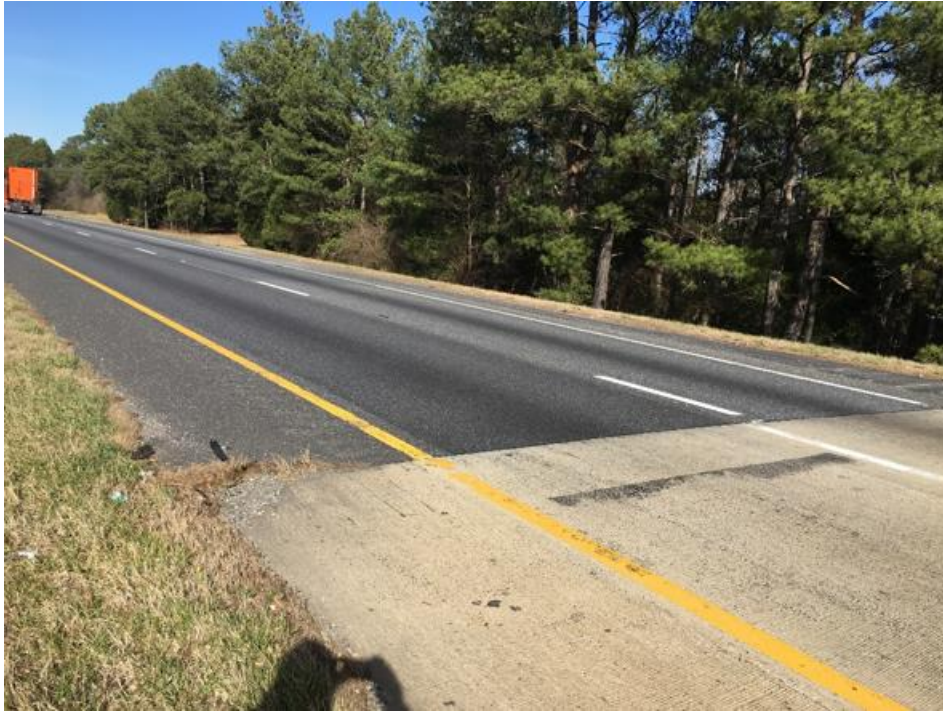
Good Bridge Departure Joints – I-77 NB at Mile Point 64.54
These joints were paved in 2013

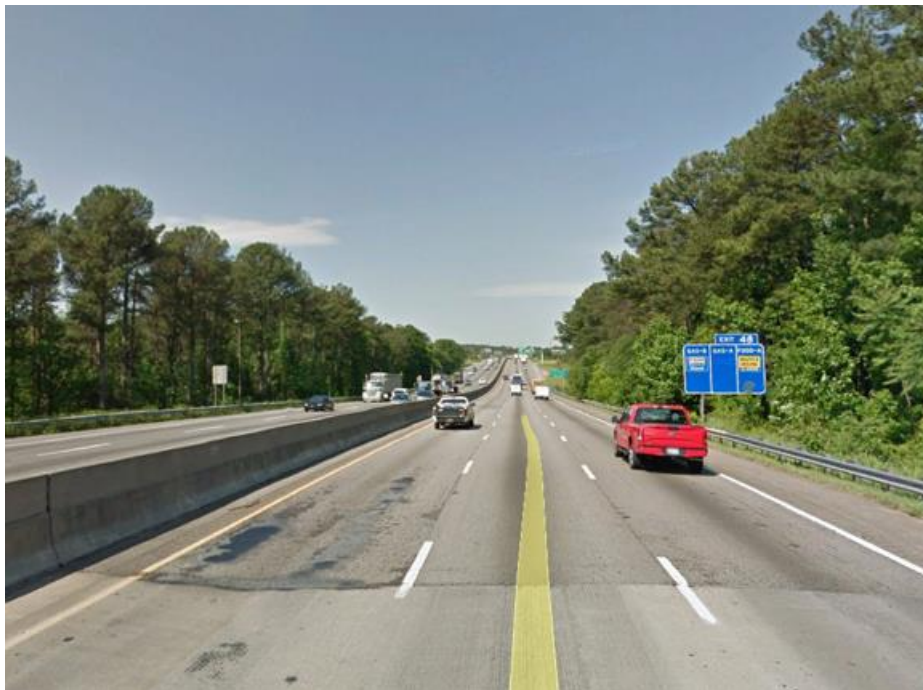
Bad Bridge Departure Joint – I-85 SB at Mile Point 48.52
This joint was paved in 2013

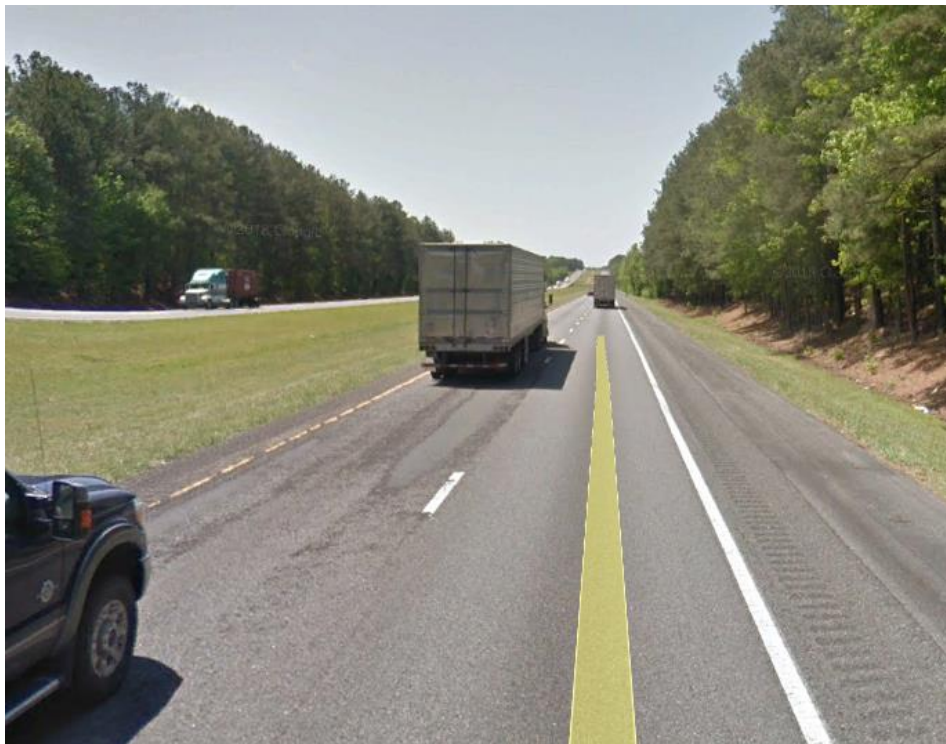
Mid-Shift Raveling – I-77 SB at Mile Point 69.0

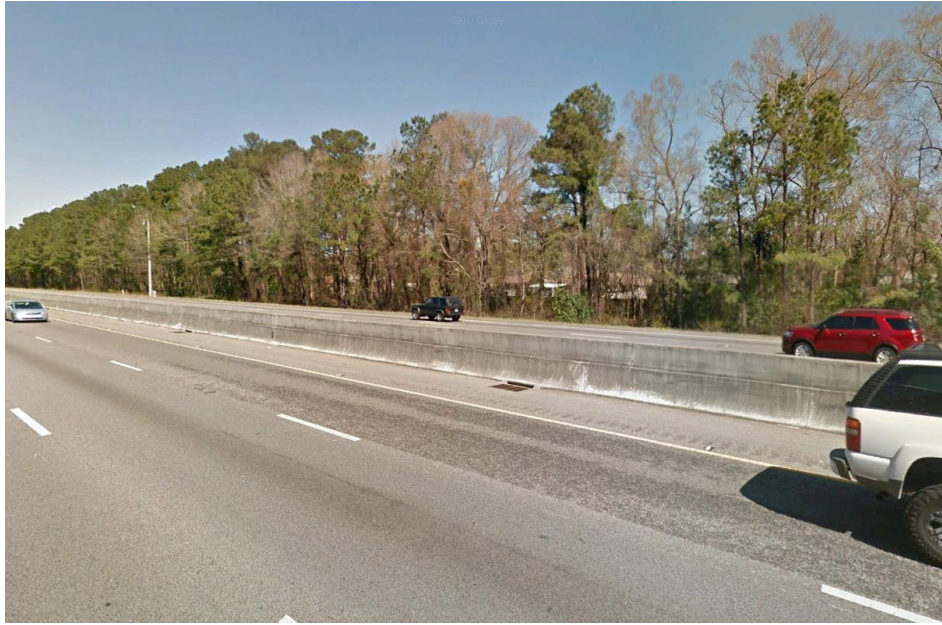
Mid-Shift Raveling – I-26 EB at Mile Point 206.8

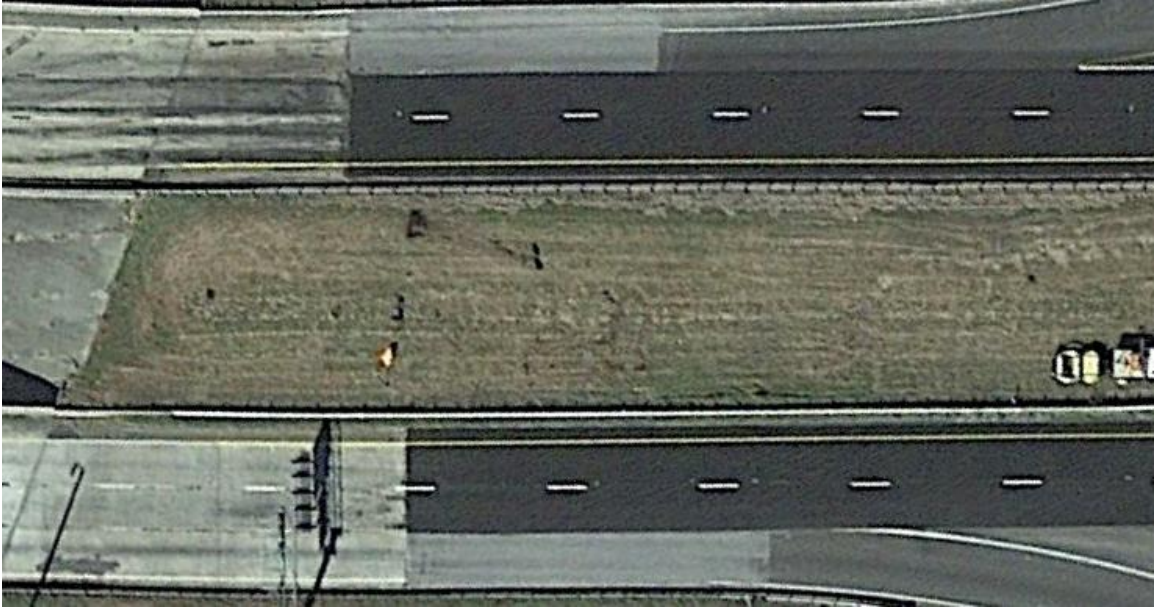
Example 1 – I-95 NB at Mile Point 85.79

This Google Earth image is dated 10/15/2012 when paving in Lane 1 and Lane 2 was complete. The ramp had not been paved when this imagery was taken but the contractor's equipment parked in the median indicates that it was paved soon after.

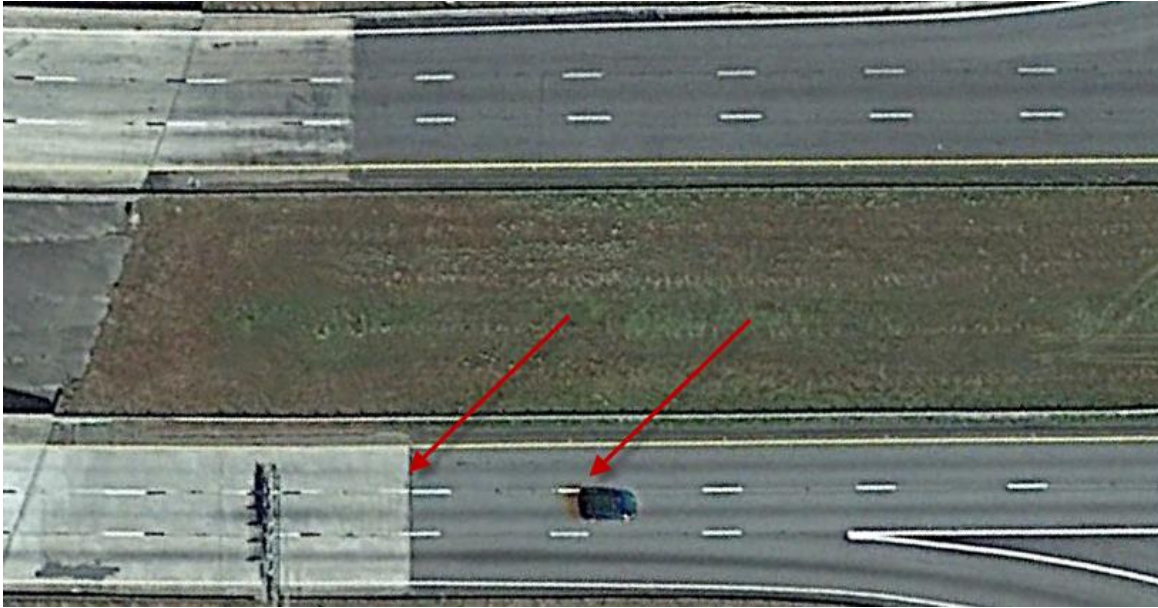
This Google Earth image is dated 5/15/2014. Issues are visible in the left travel lane.

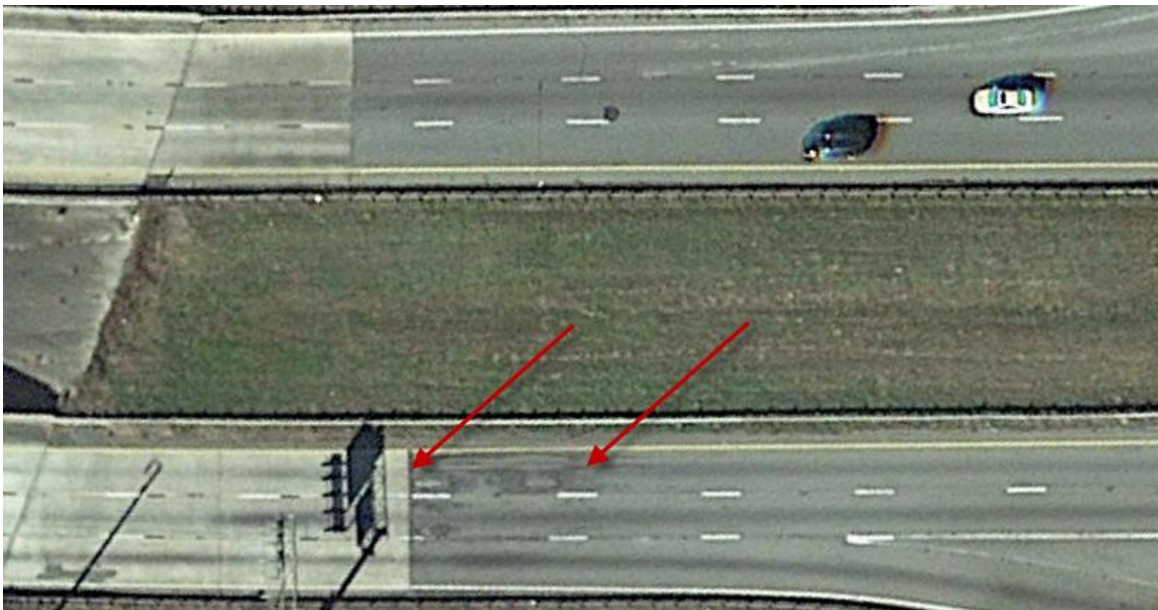
This Google Earth image is dated 11/16/2017. The OGFC in the left travel lane has raveled completely down to the underlying layer of asphalt (approximately 1") and the middle lane has begun raveling as well.

- The SCDOT expects OGFC to have a 10-year service life
- Issues were visible within 1.6 years
- **The area had completely failed before 5.1 years**

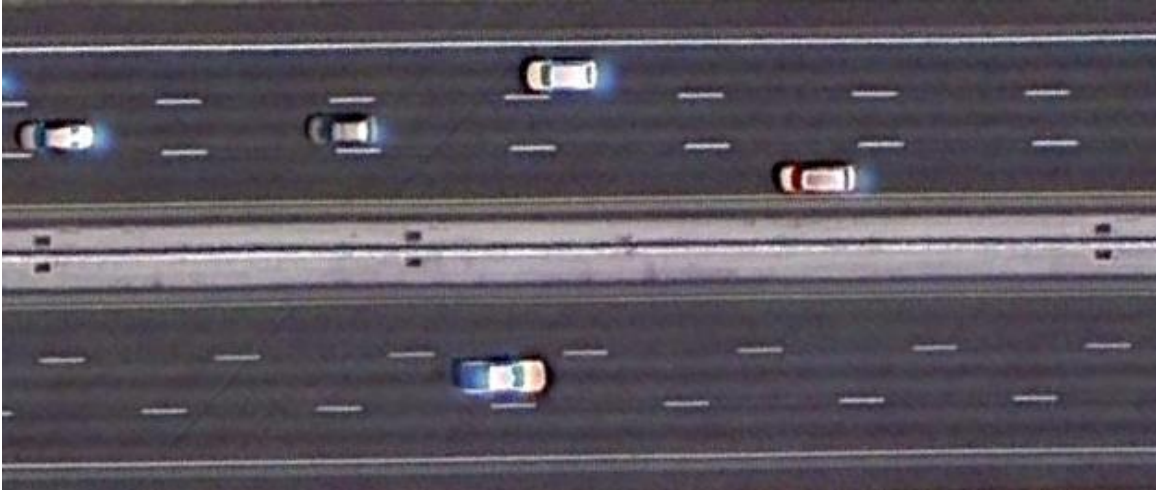
Example 2 – I-26 EB at Mile Point 206.8
Mid-Shift Raveling

This Google Earth image is dated 9/19/2010 when paving was complete.

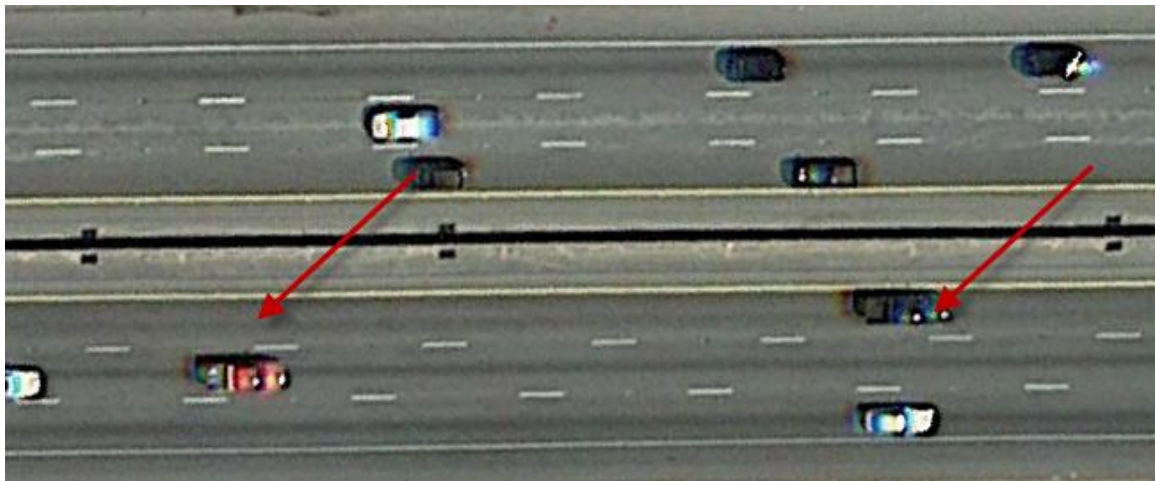
This Google Earth image is dated 3/7/2015. The two red arrows in the left travel lane match the two red arrows in the image below. A rough texture is beginning to appear where stone is beginning to ravel from the top down.

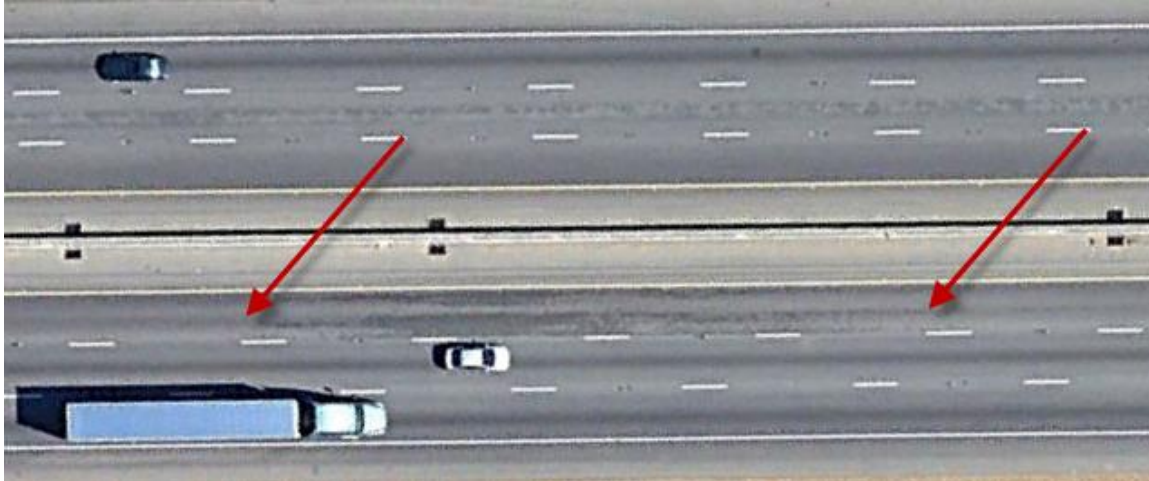
This Google Earth image is dated 2/3/2017. The OGFC in the left travel lane has raveled in parts completely down to the underlying layer of asphalt (approximately 1") and the middle lane has begun raveling as well.

- The SCDOT expects OGFC to have a 10-year service life
- Issues were visible within 4.4 years
- **The area had completely failed before 6.4 years**

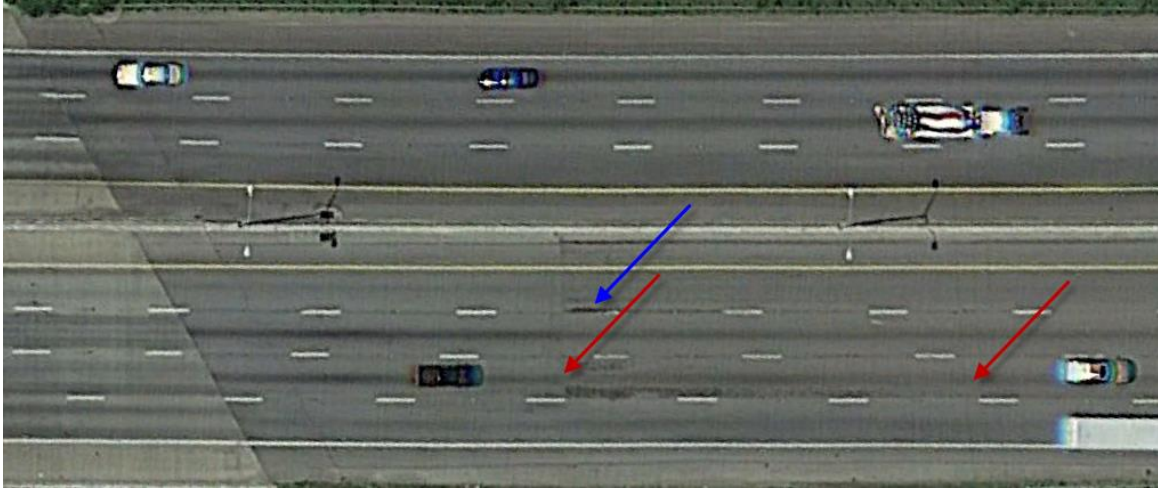
This Google Earth image is dated 6/3/2018. As indicated with the red arrows, the OGFC in the 3rd travel lane from the median wall has begun raveling in the right wheel path. The two red arrows align with the failed area in the picture below. The blue arrow shows a similar raveling area in the 1st travel lane.

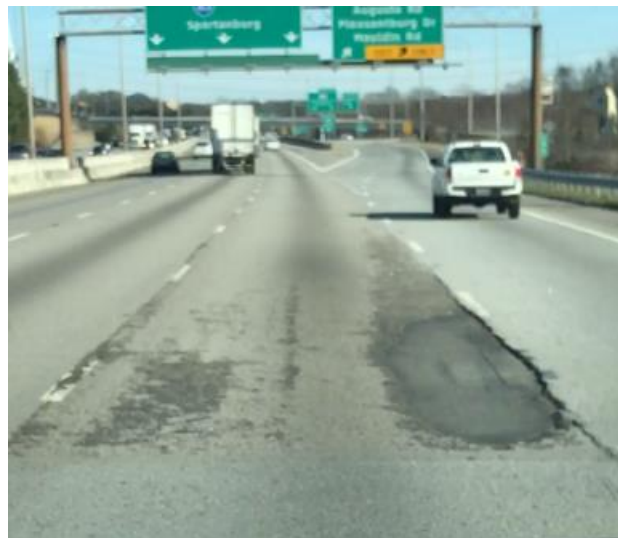
This picture was taken on 1/10/2019 by District 3 Maintenance Engineer Tony Thompson.

- The SCDOT expects OGFC to have a 10-year service life
- Issues were visible within 4.9 years
- **The area had completely failed before 5.6 years**

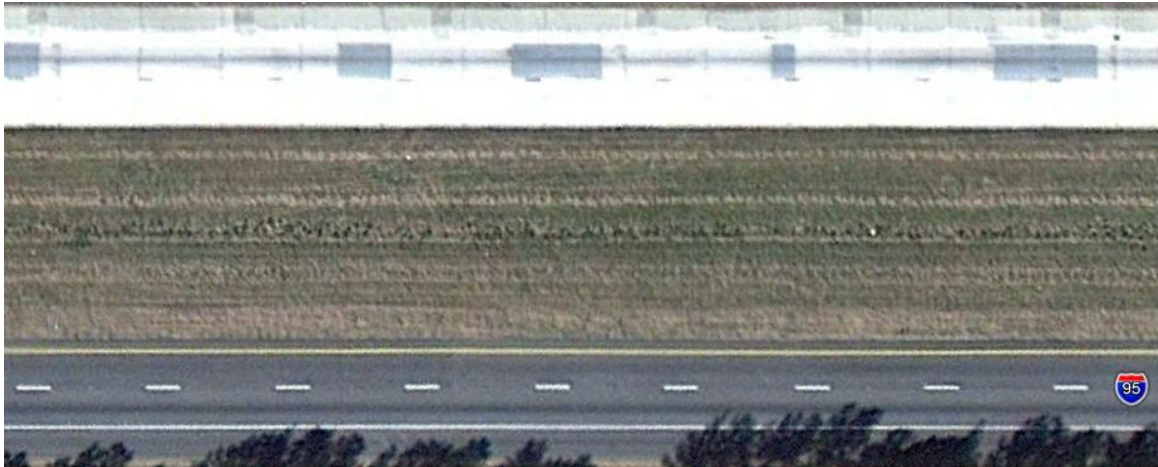
Example 4 – I-95 NB at Mile Point 186.44

This Google Earth image is dated 12/18/2011 when paving was complete. No issues are visible.

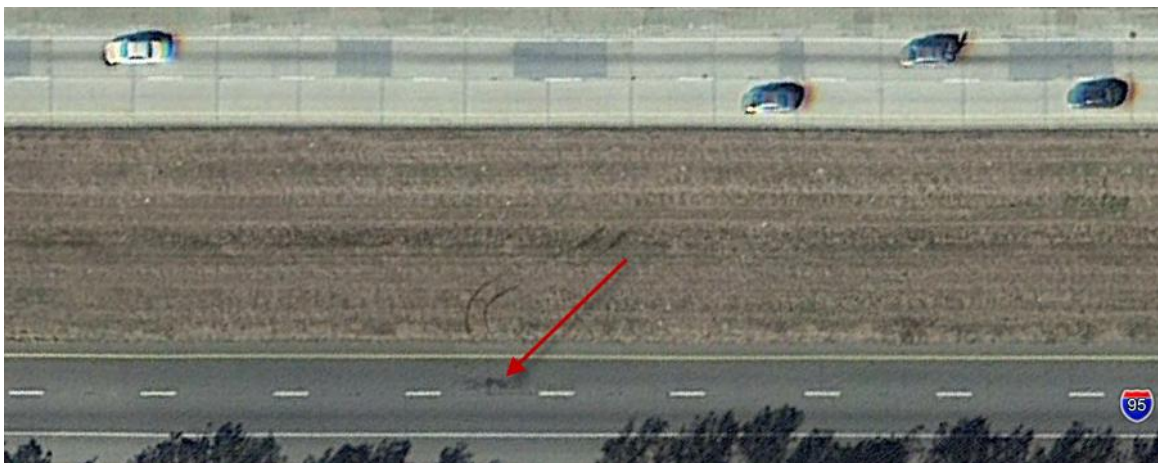
This Google Earth image is dated 1/30/2015. The red arrow indicates where raveling has begun.

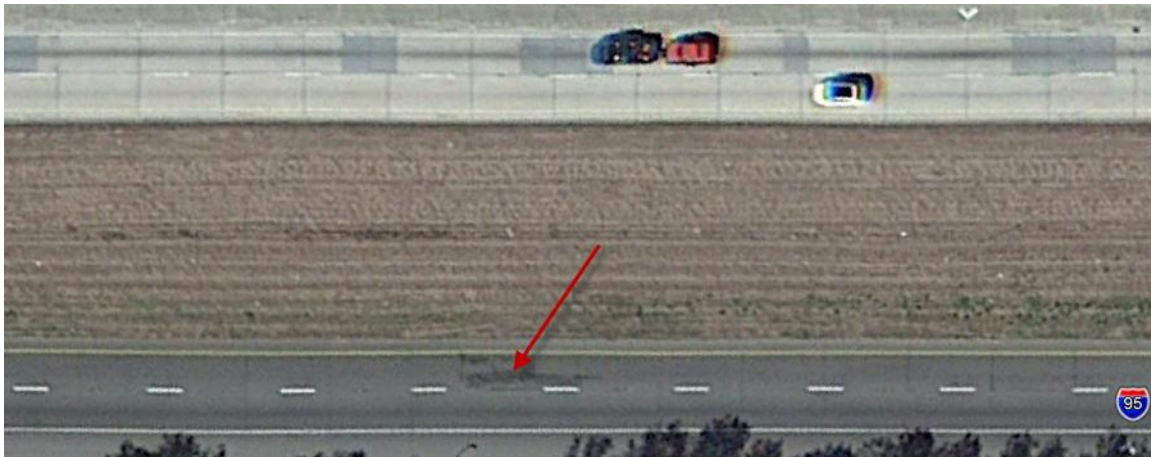
This Google Earth image is dated 2/8/2017. As indicated with the red arrow, the OGFC has substantially raveled.

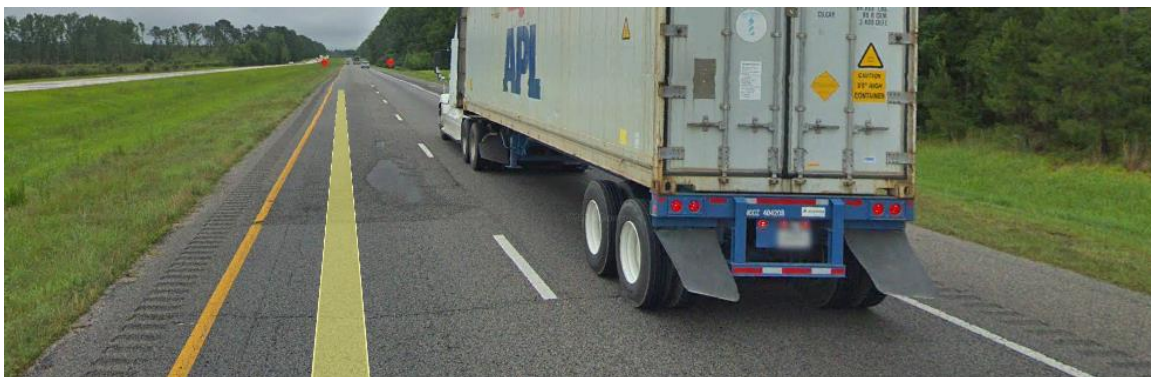
This Google Earth Street View image was taken sometime in June 2018. The OGFC in the left travel lane has raveled completely down to the underlying layer of asphalt (approximately 1") in the right wheel path and has raveled substantially in the left wheel path.

- The SCDOT expects OGFC to have a 10-year service life
- Issues were visible within 3.1 years
- **The area had completely failed before 5.1 years**
